GENESIS OILFIELD LOGISTICS BASE DEVELOPMENT NEWS

ISSUE 2: 27 JUNE 2013

GENESIS OILFIELD LOGISTICS BASE

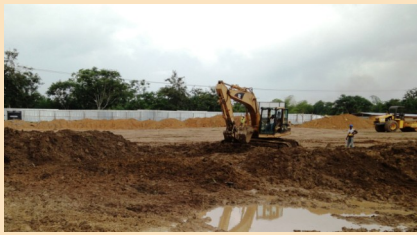
PIC 1: EARTHWORKS TO STABILIZE THE SITE BY EXCAVATING UNSUITABLE SOIL IN PREPARATION FOR LAYING OF SUB-BASE

Given the intention to use the site as a logistics facility for oilfield equipment such as OCTG casing and tubing, it is crucial that the foundations for the site are properly laid. So one of the major aspects of construction during June has been the site stabilization earthworks, which commenced once the top-soil had been stripped and the vegetative layer cleared.

Next was to begin what civil engineers refer to as “cut and fill” work. “Cutting”

involves excavating unsuitable (clayey) soil and high-lying areas in order to achieve a more even level across the entire site.

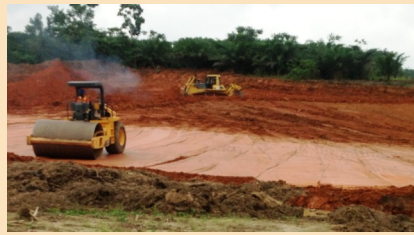
PIC 2: FILLING AND COMPACTING LOW WATERCOURSE AREAS WITH GRANULAR HARD-CORE MATERIAL

“Filling”, on the other hand, refers to the laying of more suitable material in order to raise the height of low-lying areas across the site.

In terms of quality control, the contractor and Project Manager both kept a strong focus on when and how the fill material was placed. The site stabilization earthworks have been completed successfully, and “cut and fill” work is underway.

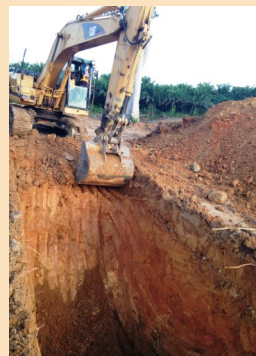
PIC 4: EXCAVATION OF DRAINAGE DITCH ON THE EAST SIDE OF THE SITE

For a site of this size (20 acres or 81,000m²) it goes without saying that the drainage system needs to be very well built from the onset. To ensure this, the areas earmarked for the drainage ditches

were re-surveyed in order to establish the appropriate “levels” and slopes before any excavation commenced. With the drainage channels having been fully excavated according to the survey results, work is ongoing to complete the concrete base (and cemented sides) of the drainage channels before month-end.

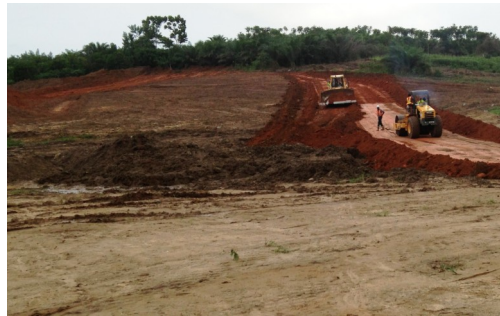
PIC 5: EARTHWORKS AND SOIL STABILIZATION CONTINUES

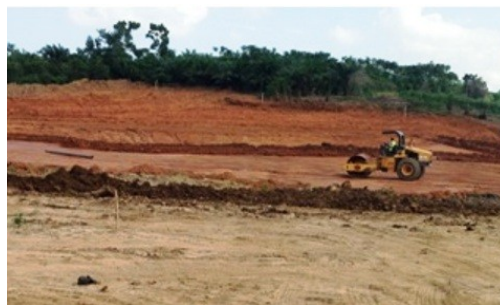
PIC 7: FILLING AND COMPACTING WATERCOURSE AREAS

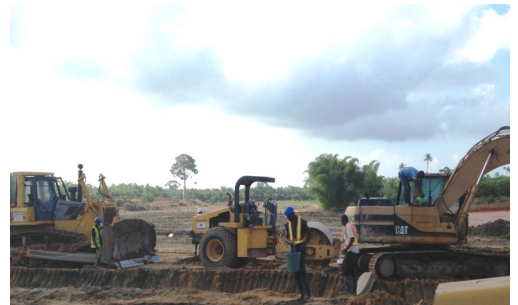
PIC 8: EQUIPMENT MOBILIZED FOR EARTHWORKS

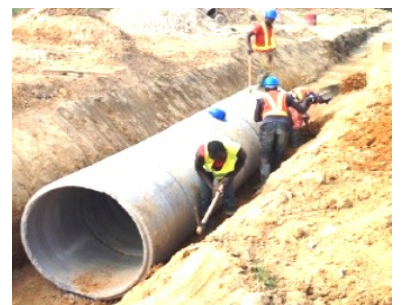
PIC 9: INSTALLATION OF CULVERT CROSSING AT THE FRONT ENTRANCE OF THE SITE

With the drainage system including a “U-drain” across the front of the site, the design engineers have incorporated a reinforced concrete culvert crossing at the front entrance to allow access to the site.

- Step1: laying a 25cm concrete foundation along the section of the U-drain on which the culvert will rest
- Step 2: placing pre-cast reinforced concrete pipes on the concrete foundation
- Step 3: Installation of timber formwork and steel reinforcements around the concrete pipes
- Step 4: Pouring concrete around the pipes to finish the culvert, and curing the concrete for a fortnight before use.

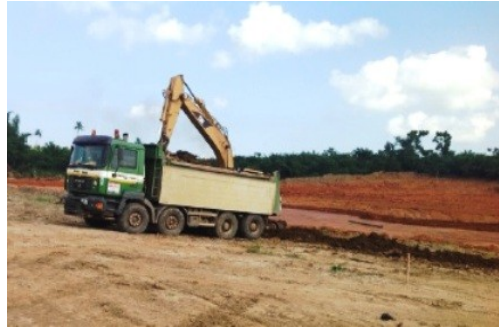
PIC 11: TIPPER TRUCK REMOVING EXCAVATED MATERIAL FROM THE SITE

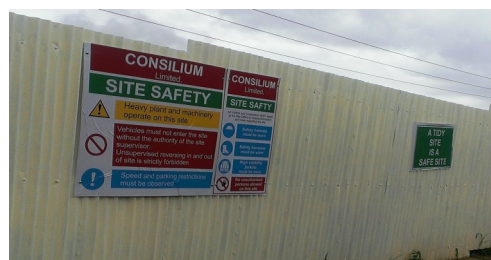
PIC 12: SITE SAFETY SIGNS HAVE BEEN PUT UP ACROSS THE ENTIRE SITE TO ENSURE THAT WORKERS AND VISITORS HAVE A VISUAL REMINDER OF SAFETY RULES DURING CONSTRUCTION

- Daily HSE briefings to increase awareness of site workers
- Rigorous enforcement of site safety rules, including with regards to the use of Personal Protective Equipment (PPE) at all times
- Safety signs put up across the site
- Weekly HSE reporting, documenting any breaches, near misses and/or accidents.
